Investigation of Finned Tubes Failure in the Furnace of Dehydration Unit at 10th Refinery of South Pars Gas Complex

^a Technical Inspection Department, South Pars Gas Complex, 10th Refinery, Kangan, Iran.

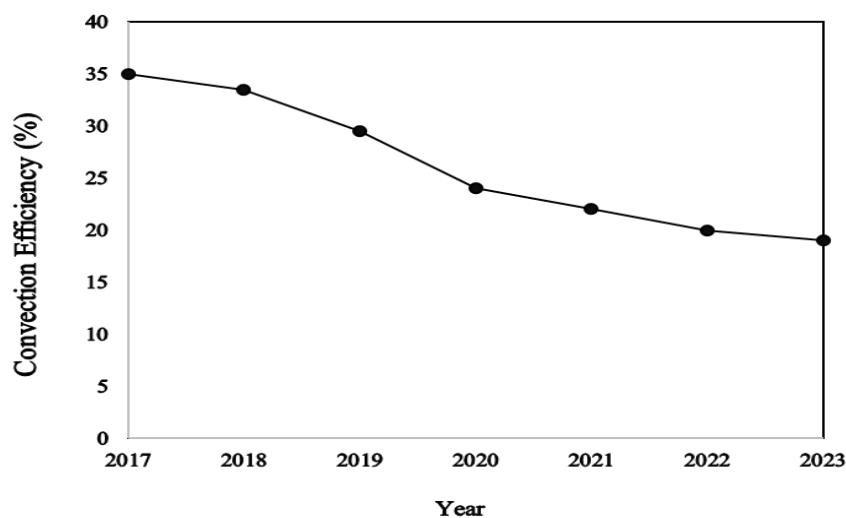
The efficiency of the convection section of the second-row furnace at the 10th refinery's second row fell from about 34% at the start of commissioning in 2017 to below 20% over time, as shown in Fig. 3.

Fig. 3. Declining trend in efficiency of the convection section of the boiler

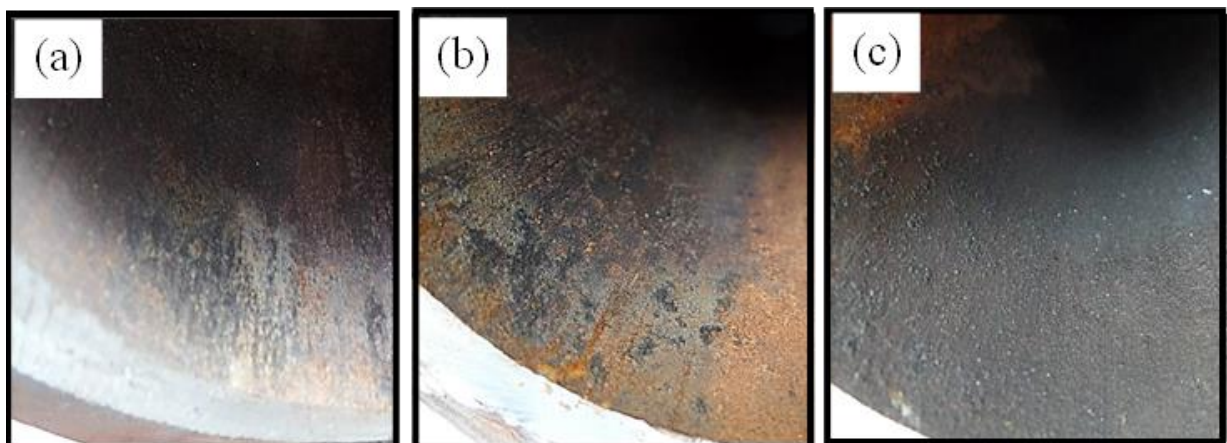
Visual Evaluation of the tube was performed by determining four hypothetical positions: 3, 6, 9, and 12 o'clock. There are some colorful deposits on the inner tube side. At the hypothetical position 12-3 and 3-6 o'clock (Fig. 4a & b) brown and black products are clearly seen, also at the hypothetical position 6-9 o'clock (Fig. 4c) only black products are observed besides shallow holes, however only at the hypothetical position 6 o'clock, radial cracks are observed in the fins along the tube (Fig. 4). Also, the cracks in the tube and the radial cracks in the fin section are connected (Fig. 5). Considering the connection of the cracks in the fin and tube and their alignment, there is a possibility that the origin of the crack initiation is the same in both.

Fig. 4. Formation of deposits at (a) 12-3 o'clock, (b) 3-6 o'clock, and (c) 6-12 o'clock hypothetical positions

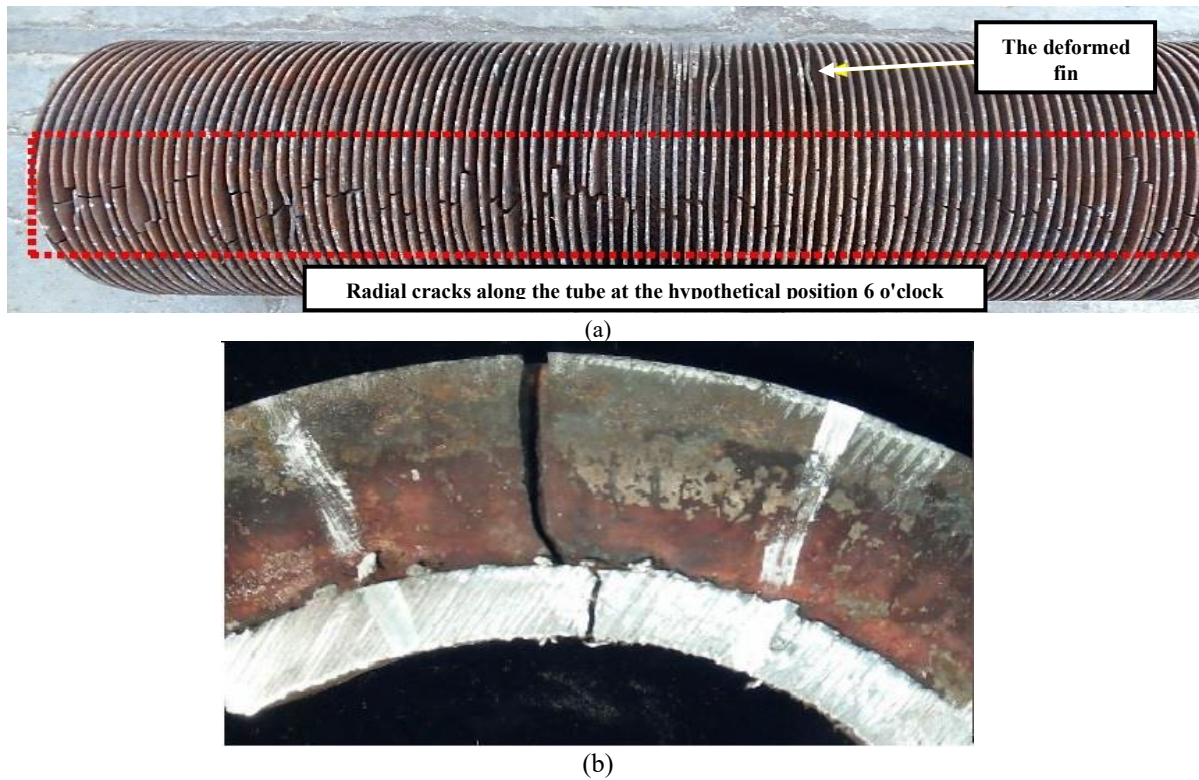
Fig. 5. (a) Radial cracks on the fin, and (b) crack propagation in both the tube and the fin

- Based on visual inspections, all cracks occurred at the hypothetical 6 o'clock position, and the cracks in the fin and tube were not only aligned but also connected.

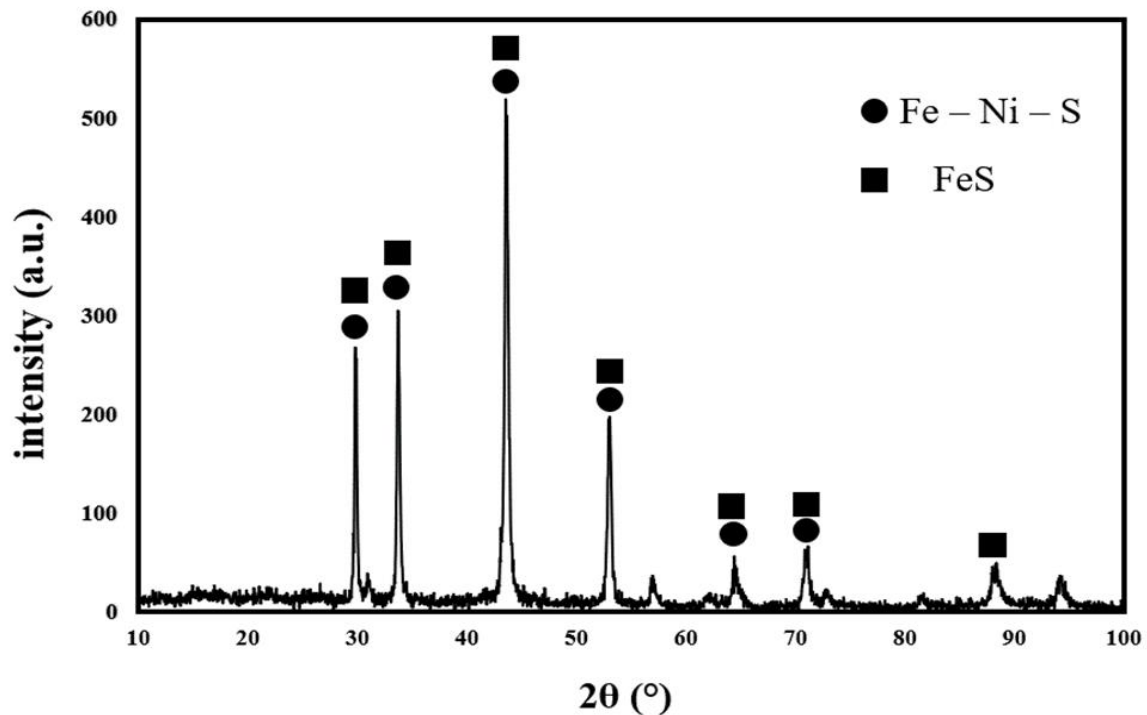
The tube's internal surface deposit structure was investigated by XRD analysis. Fig. 6 illustrates the XRD pattern of the tube's internal surface deposits. As shown in Fig. 6, two reference codes matched the detected peaks in the XRD pattern. Reference code JCPDS 969013705 for Fe-Ni-S compound (Fe_{43.96}Ni_{4.00}S_{49.00}) named Pyrrhotite with Monoclinic structure has seven detected peaks at diffraction angle 29.85°, 33.75°, 43.61°, 53.01°, 57.03°, 64.52°, 71.00° can be assigned to (025), (043), (046), (065), (228), (445), (086) crystallographic planes of the Fe-Ni-S compound respectively. Also, the peaks detected by JCPDS 961504401 reference code is about FeS with Hexagonal structure at the diffraction angle of 29.82°, 33.69°, 43.49°, 52.94°, 56.78°, 64.44°, 70.85° and 88.30° that could be related to (100), (101), (102), (110), (103), (004), (202) and (114) crystallographic planes. Based on the detected phases, it can be noted that the sulfide products have formed on the inner surface of the tube.

Fig. 6. XRD patterns of tube internal surface deposits

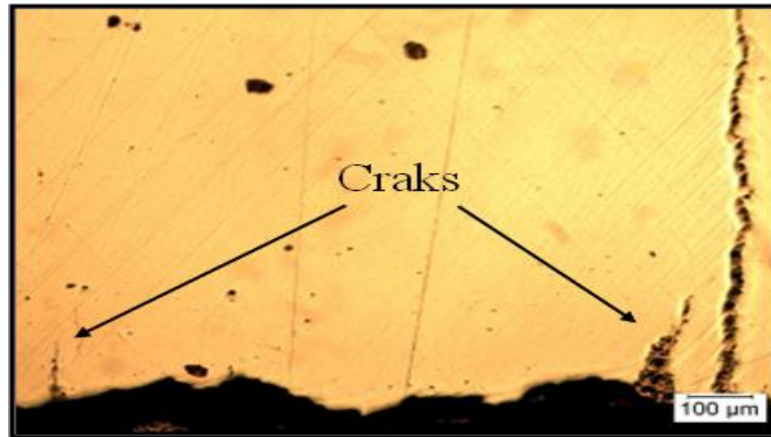
Microscopic examination of the tube cross-section reveals the presence of multiple parallel cracks exhibiting both sharp and occasionally rounded (Fig. 7). First, by etching the boundary between the fin and the tube with 2% Nitrel solution, ferrite grains along with pearlite rows were visible in the tube structure. The cracks have grown intra-granularly in this part (Fig. 8). Also, microscopic defects were visible at the boundary of the fin-tube connection (Fig. 9). The heat-affected zone (HAZ) on the tube side predominantly comprises a ferritic matrix with a dispersed distribution of carbides and localized pearlitic regions. Microstructural analysis indicates that crack propagation occurred trans-granularly (Fig. 10). The observed features are attributed to the high thermal input during welding and the absence of subsequent post-weld heat treatment (Table 11). The microscopic structure in this area has changed, transitioning from fine-grained to coarse-grained (Fig. 9), resulting in residual stresses in this region. The interaction between residual stresses and operational thermal stresses arising from the continuous exposure of these tubes to fluctuating thermal cycles can facilitate the detachment of the fin from the tube. Also, the coarse-grained area is prone to the initiation or propagation of other cracks into the tube. Therefore, improper welding and residual stresses are among the causes of microscopic defects at the fin-tube junction. It should be noted that, in some areas, the defective fin-tube junction is likely to deposit corrosion products (Fig. 11).

Fig. 7. Multiple microcracks with sharp points on the tube

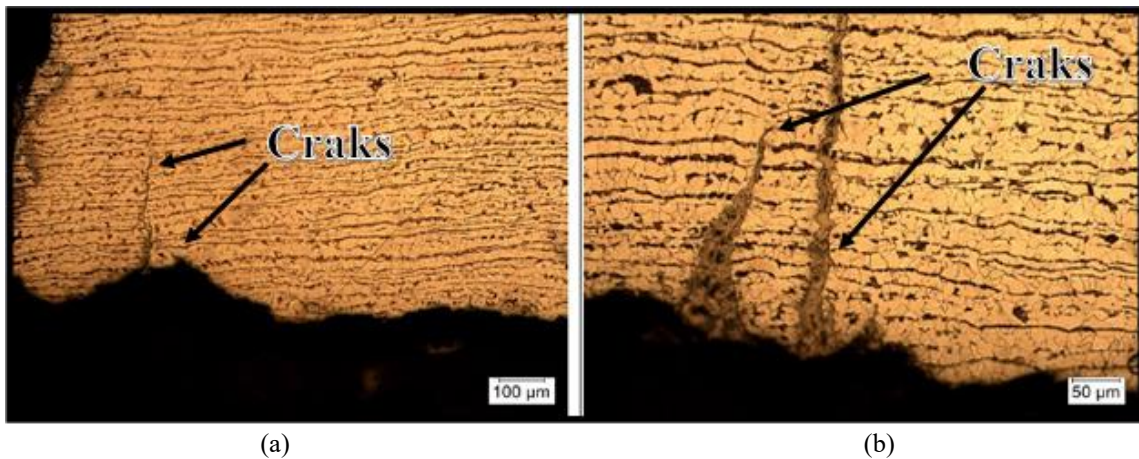
Fig. 8. Crack propagation intra-granularly in the tube internal side at scale: (a) 100 µm, and (b) 50 µm

- By examining the microscopic structure of the tube, in addition to the appearance of intra-grain crack growth, a coarse-grained HAZ structure is visible at the fin connection boundary.

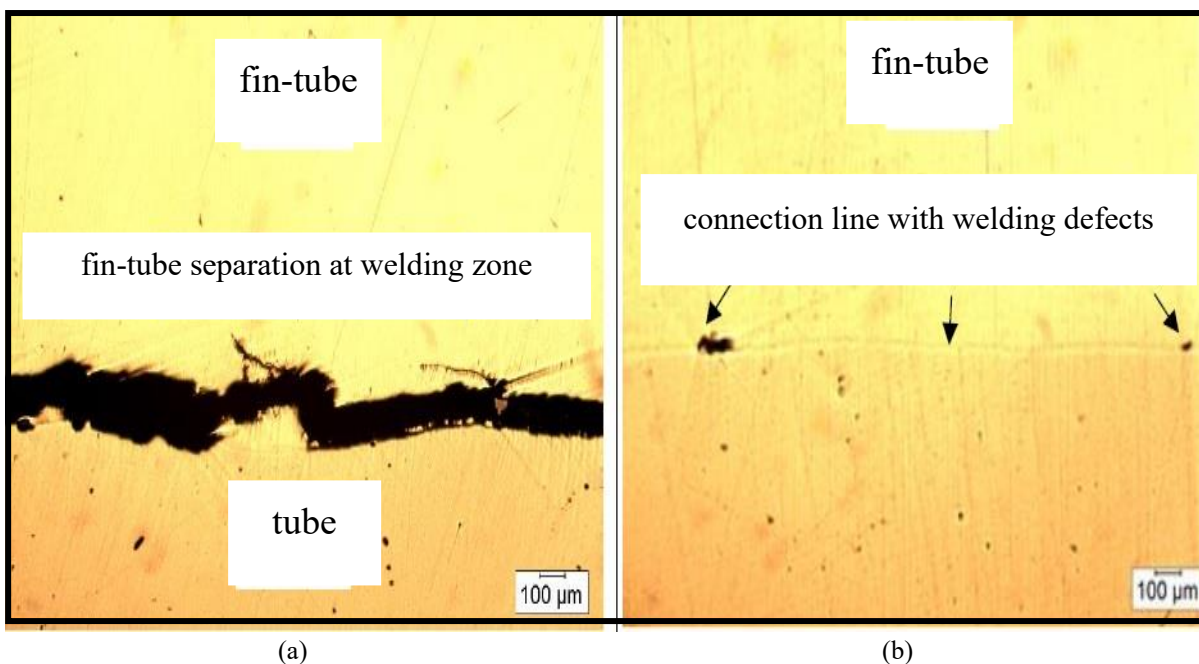
Fig. 9. (a) Fin-tube separation at the welding zone, and (b) welding defects along the fin-tube connection line

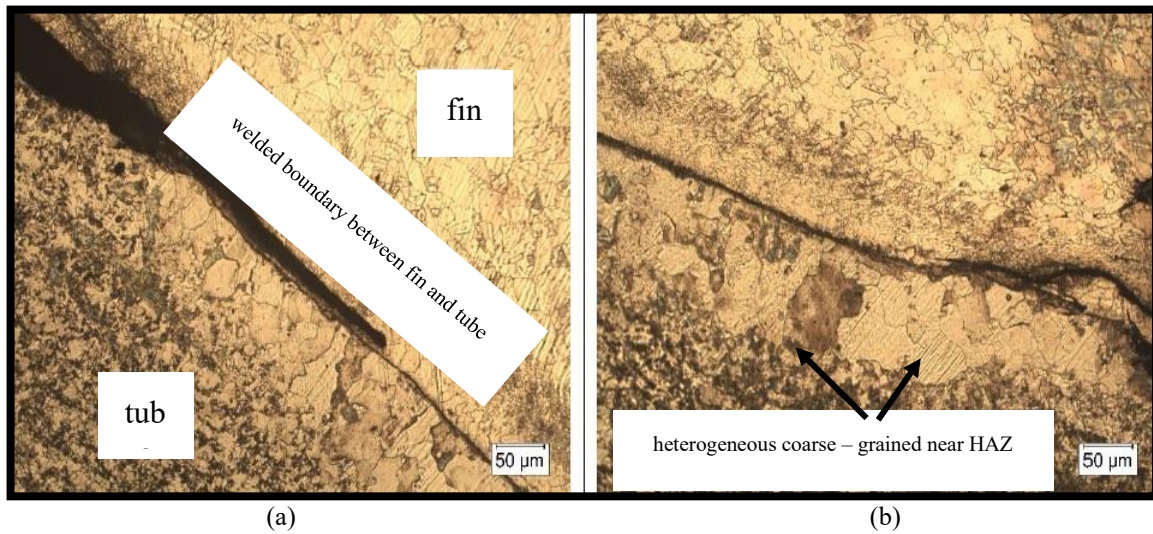
Fig. 10. (a) Welded boundary between fin and tube, and (b) coarse-grained structure near the weld line

Regarding post-heat treatment, attention should be paid to the potential for sigma phase formation in 304 stainless steel [22]. Therefore, performing solution annealing at a temperature above the sigma-phase formation range (590–870 °C) can inhibit sigma-phase precipitation in the fin and promote microstructural refinement in the tube section from coarse-grained to fine-grained while simultaneously eliminating sensitized grain boundaries within the fin region.

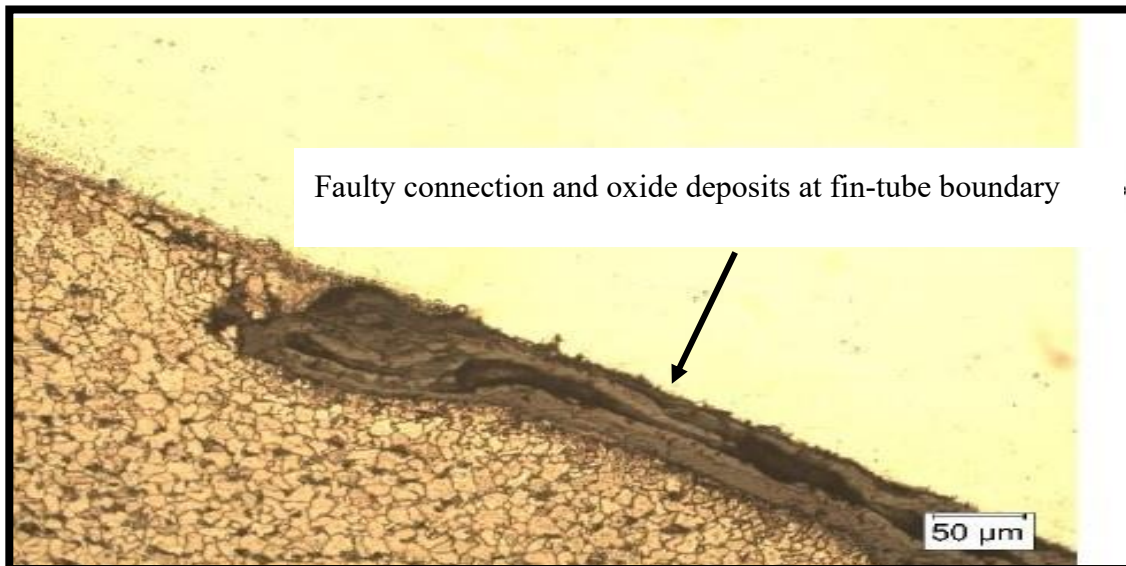
Fig. 11. Faulty connection at fin-tube boundary

Due to the difference in the heat transfer coefficient of the materials used in the fin and the tube (tube material: ASTM A106 grade B, fin material: AISI 304), the presence of numerous welding defects, and the accumulation of impurities among these defects, heat transfer from the fin surface to the tube has not taken place properly, and the fin surface has become the location of heat concentration (the fin surface temperature, according to field surveys, was in the range of 700 to 800 °C) [16]. This heat concentration in the fin creates difficulties, such as the formation of chromium carbide (at temperatures above 500 °C, the probability of its formation increases greatly) at grain boundaries. Afterward, due to a mismatch in the coefficients of thermal expansion and the localized heat distribution between the fin and tube, intergranular parallel cracks propagated toward the tube surface. This phenomenon is further attributed to the presence of chromium carbides within the fin region. These cracks are due to the coarse-grained structure in the weld area, which has weaker mechanical properties than the rest of the tube. The aforementioned cracks continued until they reached the tube's inner surface, after which leakage from the tube began, and a fire occurred. By etching the longitudinal section of the fin with glycyrrhizin solution and the transverse section of the fin with oxalic acid, austenite grains

- Owing to the difference in the heat transfer coefficient of the materials used in the fin and the tube, and faulty heat transfer from the fin surface to the tube, which results in heat concentration and formation of chromium carbide at the grain boundaries, crack propagation begins, which leads to failure.

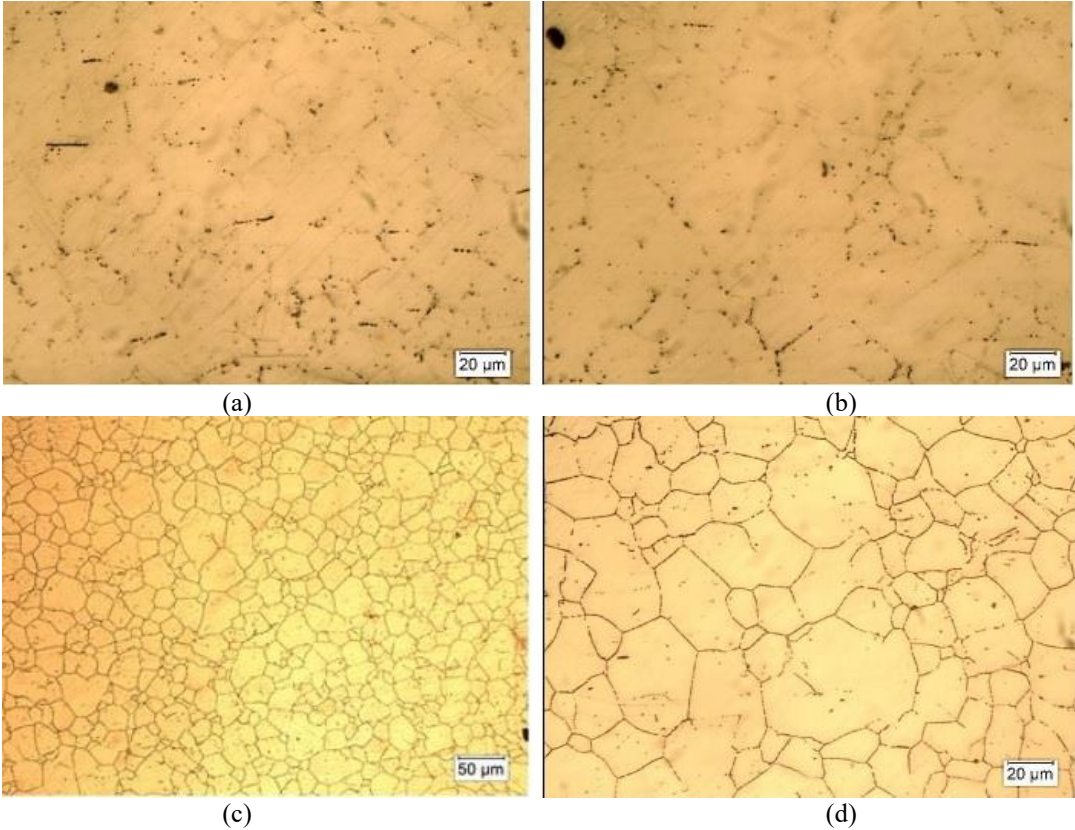
with distribution of chromium carbide particles at the grain boundaries can be seen (Figs. 12 & 13). Also, cracks in the fin section were between grains, indicating steel sensitization (Fig. 14).

Fig. 12. (a & b) Longitudinal section of the fin, and (c & d) fin cross-section after etching

- By evaluating the microscopic structure of the fin after etching, in addition to the grain boundary crack growth, the accumulation of chromium carbide at the grain boundary is also evident.

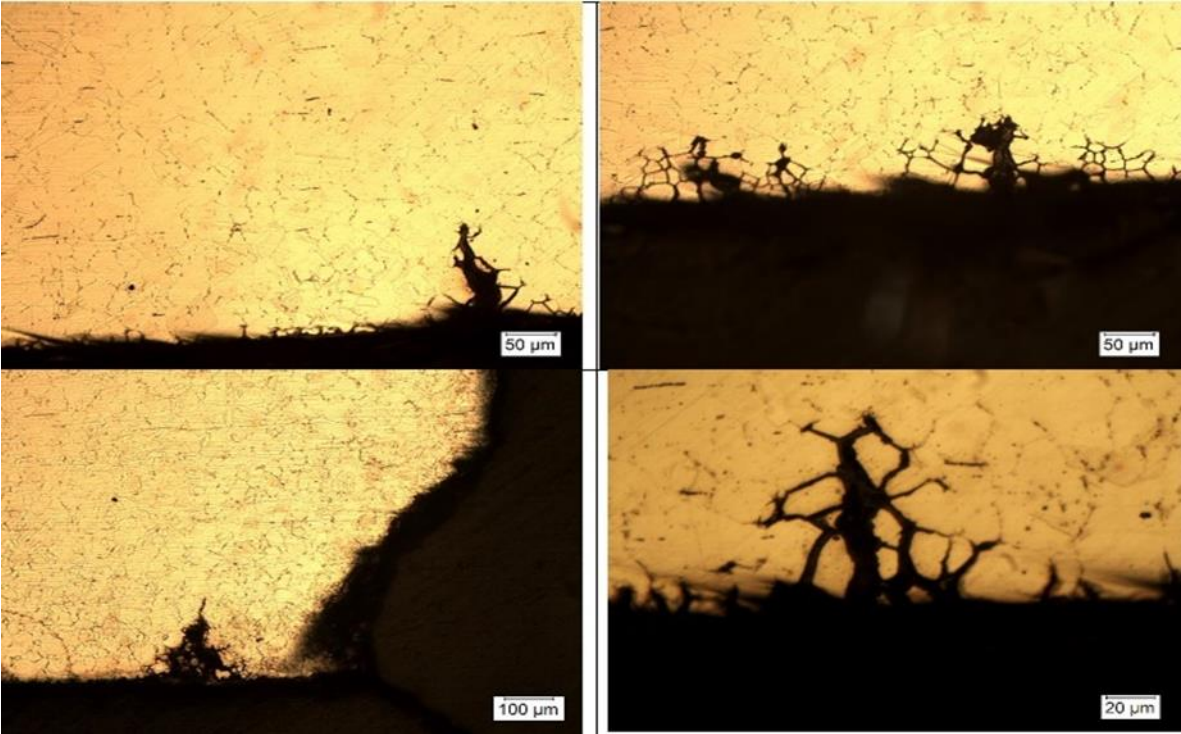
Fig. 13. Crack propagation in the fin section from the grain boundary at different scales

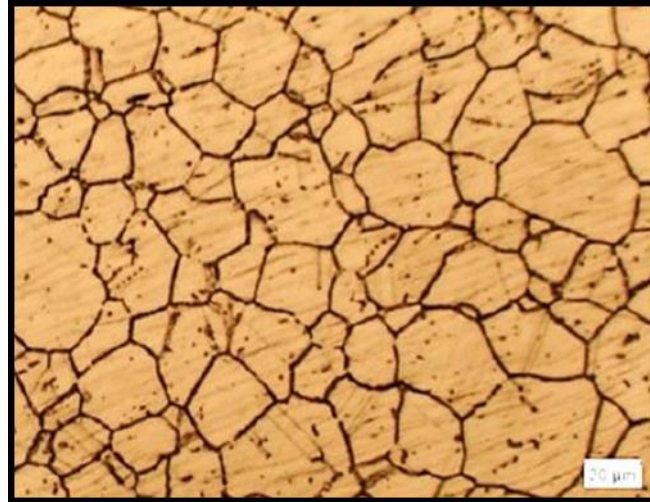
Fig. 14 shows that, according to ASTM A262-15 Practice A, the fin surface is dual-structured, and its grain boundaries are sensitive and no longer resistant to grain boundary corrosion.

Fig. 14. Dual fin microstructure

- Grain boundary corrosion sensitivity testing revealed that the grain boundaries exhibited insufficient resistance to intergranular corrosion.
- The results of the FESEM test show, besides the grain boundary crack growth in the fin section, there are some oxide and sulfide compounds in the inner part of the tube and on the fin surface, which confirms the occurrence of high-temperature oxidation and sulfidation processes.

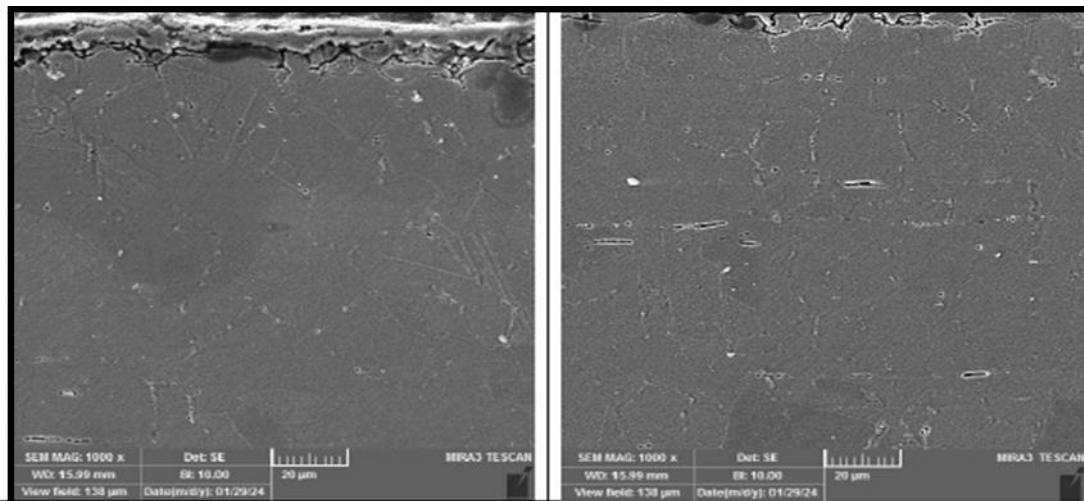
Fig. 15 is a longitudinal cross-section of the fin after etching, in which the growth of cracks between the grains can be seen.

Fig. 15. Cracks propagation between the grains of the fin on two different sides

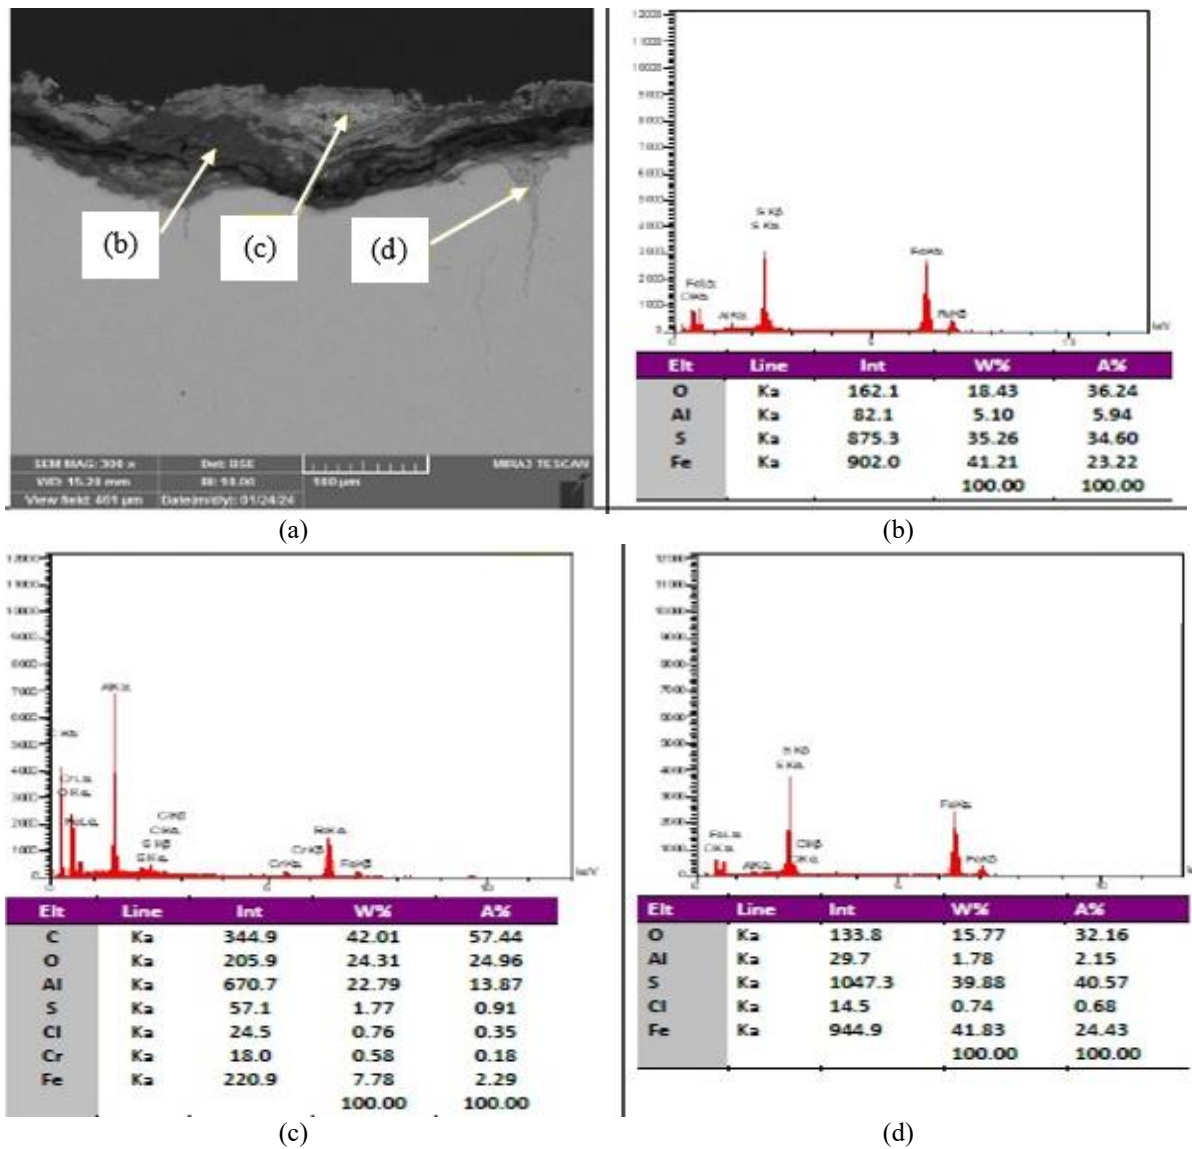
Sulfidation, also called sulfide corrosion, is a form of corrosion that occurs when sulfide compounds penetrate the alloy at high temperatures, leading to localized corrosion [23, 24]. According to the studies of the deposits in the cracks of the tube and the fin inner surface by energy dispersive X-ray spectroscopy (EDS test), the formation of sulfide and oxide compounds was quite evident. The presence of these compounds indicates sulfide corrosion and oxidation during crack propagation along the fin and tube surfaces, and a high percentage of Sulfur (S) confirms sulfidation (Fig. 16) [25, 26]. Based on the EDS extracted data, the Cl element is observed. Because of high humidity and proximity to the sea, the formation of chloride compounds is possible. High concentrations of iron, chromium, and sulfur, and the formation

of a sulfide phase, are evident in the EDS data (Fig. 17). The sulfidation on the fin surface indicates that the tube has been operating under service conditions in environments containing S and H₂S at high temperatures [27]. Fig. 17 shows that the deposit layer has penetrated the grain boundaries beneath the fin surface, and that cracks have spread into these grain boundaries [28].

Fig. 16. (a) FE-SEM image taken from the inner surface of the tube, and (b-d) EDS analyses of 3 random points

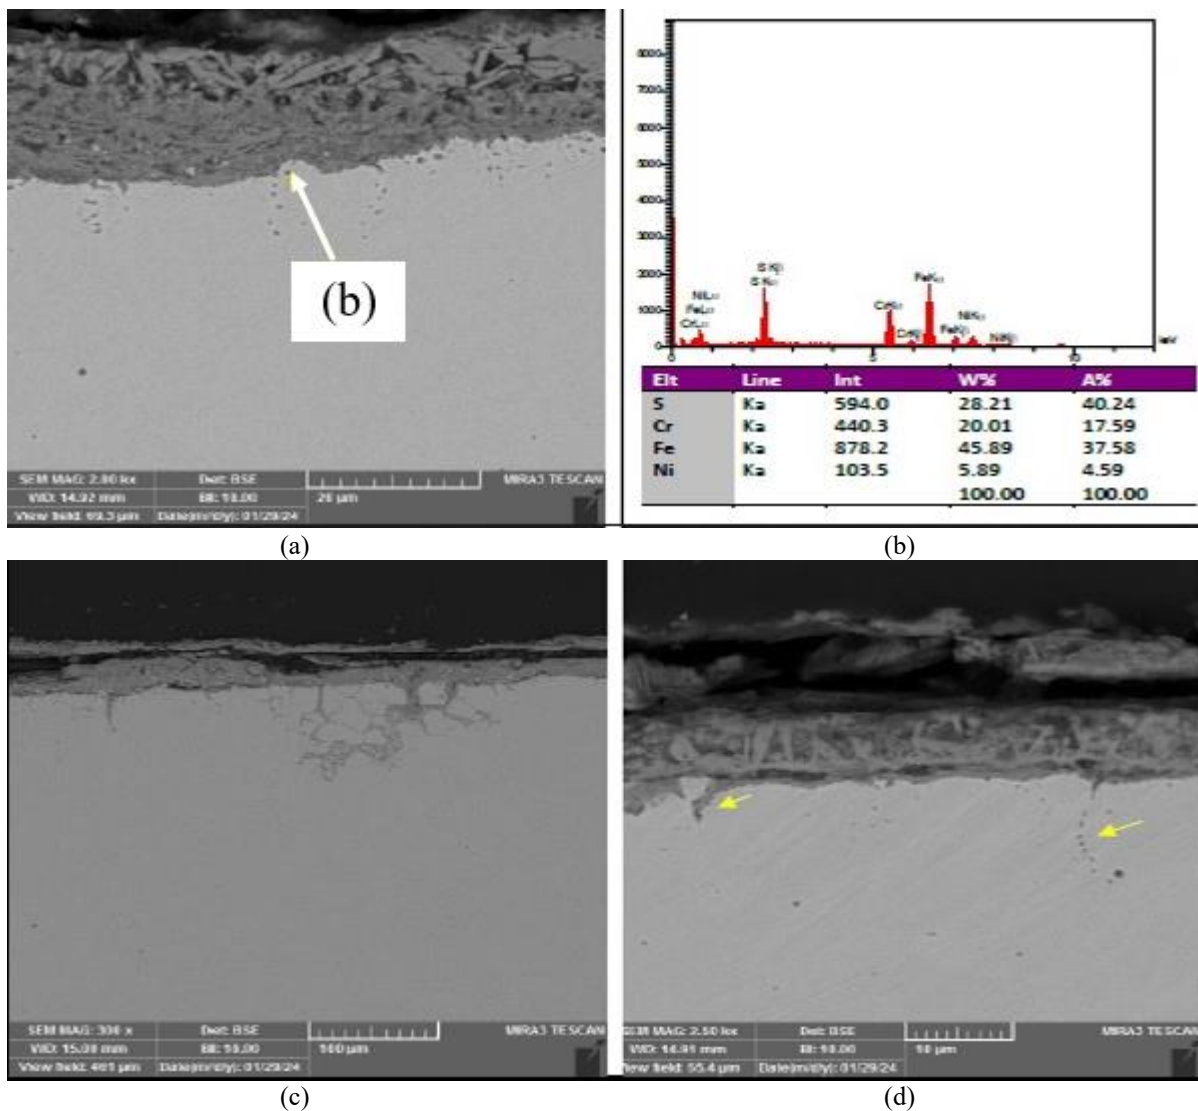
Fig. 19. (a) FE-SEM image taken from the inner surface of the fin surface, (b) EDS analysis of a random point, and (c & d) cross-section of the fin surface at two different scales
